WEATHERING

ABOUT ACCOYA®

V12.15 – these guidelines have been written for professionals wishing to use Accoya to create beautiful, reliable and highly durable end products. Should you require further information or have any comments about this document, please contact Accsys through www.accoya.com.

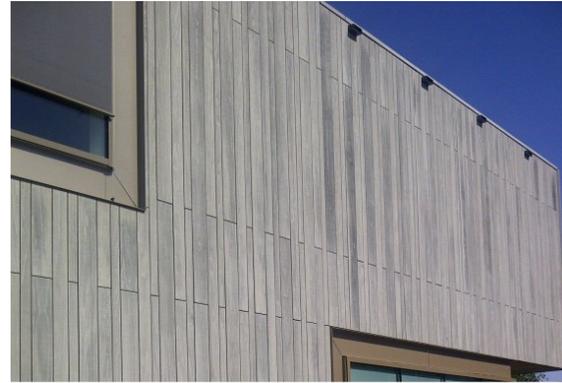
An example of such a blotchy transition period is shown in the image above (Dutch cladding project approximately a year after installation).

However, prior to turning grey, uncoated Accoya will go through a phase of bleaching where it turns a lighter shade of its normal colour. Surface growths are particularly apparent in this intervening period and can vary in level from board to board. This will become less distinguishable and objectionable after full (even) greying, but in this transition period the surface of Accoya may look blotchy.

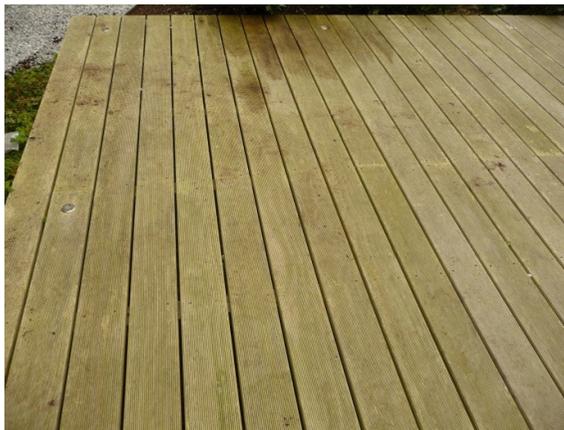
Shaded areas may promote development of algae.

A wet and a dry board may vary in appearance. Due to the installation details, the presence of a shaded area and the natural differences in the wood between boards, as for instance density variation or grain orientation, some may dry quicker than others.

Not only does this reflect on the appearance of a surface while drying, it will also have an influence on the development of moulds, algae and so on.

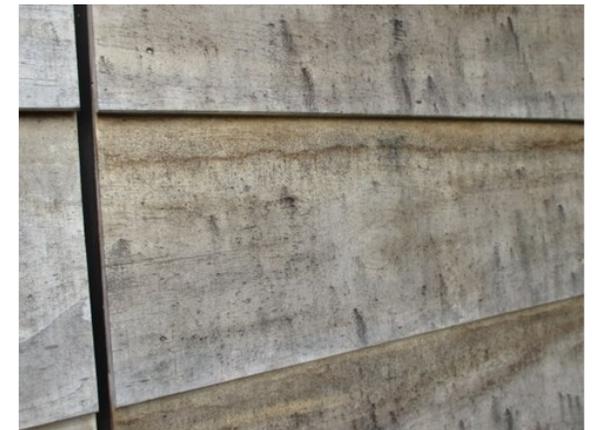
Rough sawn surfaces are more conducive to build-up.

Other influences are location specific, such as proximity to vegetation, pollution and dirt accumulation (rough sawn surface!). Lastly, the natural differences in the wood will also play a role.

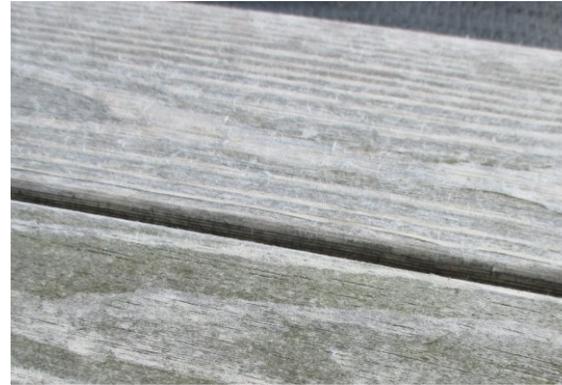
Natural occurring surface fibres on decking.

The higher the amount or intensity of UV the surface is subject to, the faster this process will develop. It should be noted that these fibres are formed on all exposed wood species, including Accoya, particularly on flat surfaces like decking. A ribbed deck profile will tend to cause an accumulation of these fibres, making it all the more noticeable.

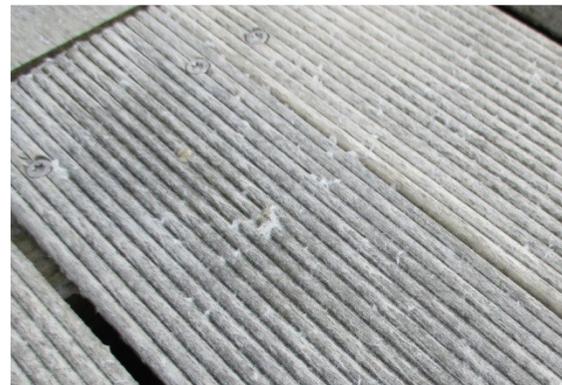
Fibres may get trapped in ribbed surface profiling.

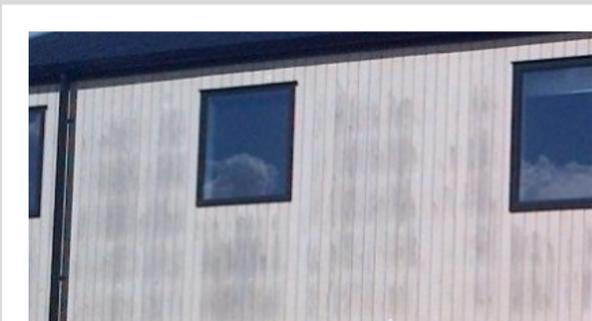
A New-Zealand housing project with a very distinct batten silhouette showing in the cladding surface.

Some projects have shown a distinct pattern reflecting the sub-frame behind the Accoya. This is caused by heat transferal from the building to the Accoya boards, which will decrease the average moisture content at the location of the interface.

Dryer conditions mean less mould growth, which is why the interfaces are clear where the rest of the board surface shows mould. Note that this effect can be observed on any façade with any kind of cladding or panelling material.

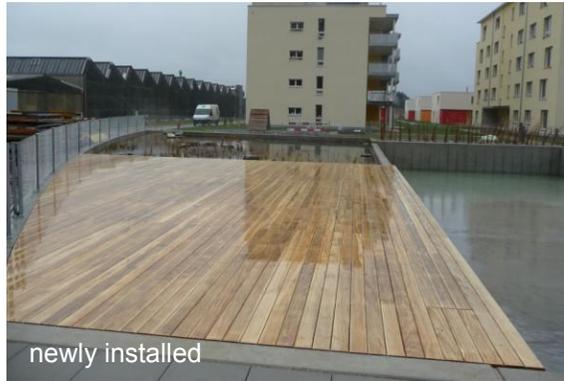
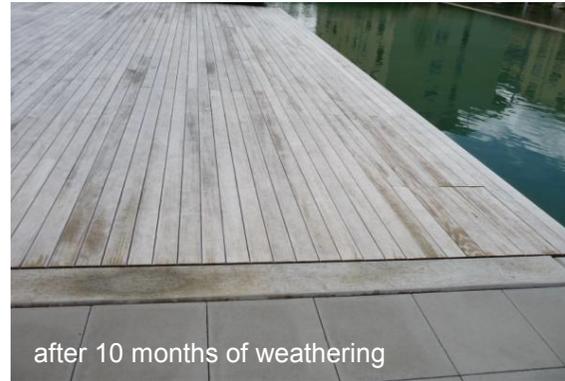
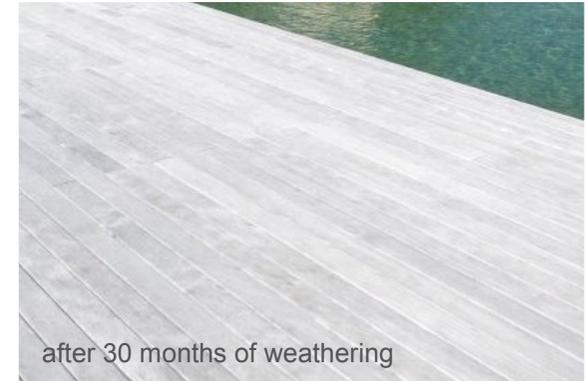
PUBLIC POOL DECKING, OESINGEN, SWITZERLAND.

This deck in Oesingen was photographed when newly installed (left), after 10 months (middle) and after 30 months of weathering (right).

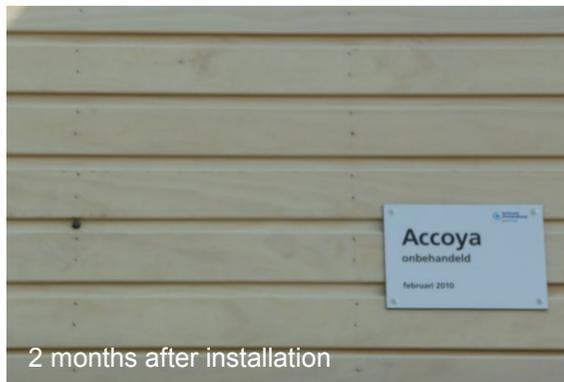
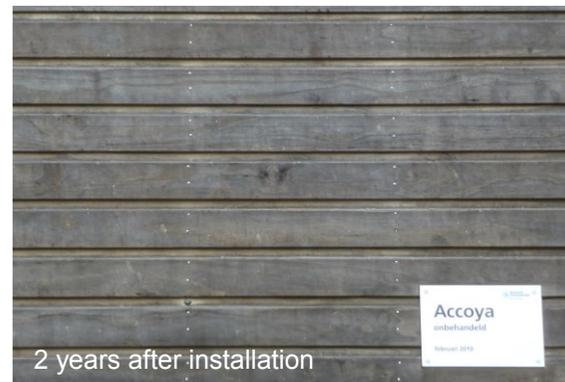
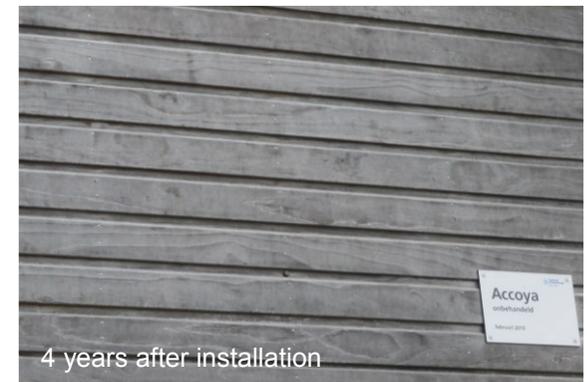
OFFICE CLADDING, VROOMS- HOOP, THE NETHERLANDS

A part of the South facing façade was cladded with Accoya in April 2010, with no maintenance since. The pictures below (left to right) show this cladding in July 2010, 2012 and 2014.

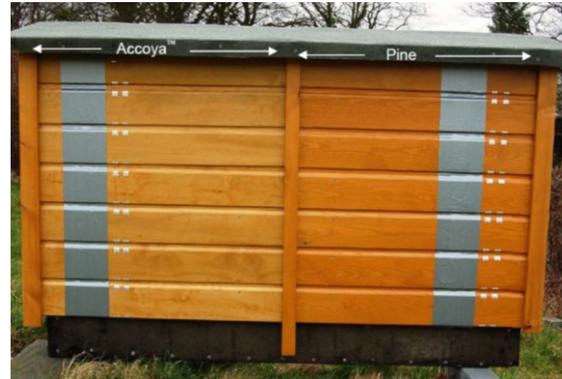
Test set-up at the start of the exposure in February 2008

A south-facing cladding rig was set up at BM Trada for the comparative performance evaluation of Accoya and unmodified pine coated with a semi-translucent stain.

The translucent stain system consisted of a pigmented primer with two topcoats. The cladding boards used were machined to a rebated shiplap profile with the upper edge rounded to a radius of $\pm 10\text{mm}$.

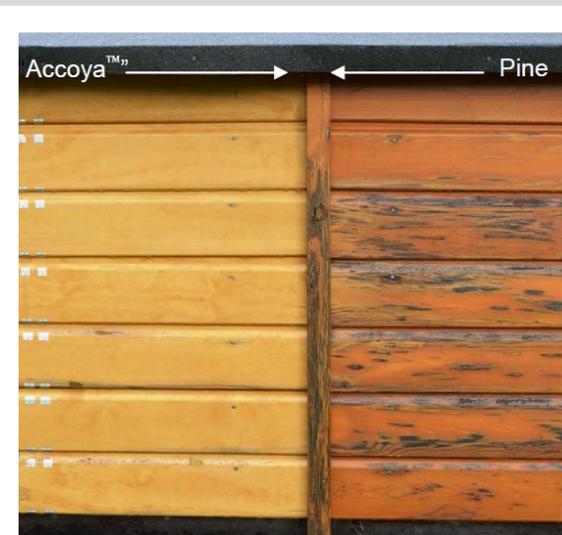
Test set-up after 7 years of exposure in January 2015

After nearly 7 years of south-facing exposure in a challenging environment the Accoya boards were found to be in a largely serviceable condition with only 2 of the 7 cladding boards showing discernible evidence of stress in the form of mould or mildew growth.

The pine boards were found to have developed severe blue-stain disfigurement leading to patchy and discontinuous disfigurement beneath the coating. The integrity of the coating on the pine boards was found to be severely compromised. Severe flaking and peeling of the coating had occurred not only along the rounded shoulder details but also on the flat faces where surface fissures and checking had occurred.
